# Fiber Orientation in Fiber-Reinforced Plastics and How it Affects Automotive Applications

E. M. Rowbotham  
Ford Motor Co., Ltd.

Automotive Engineering Congress  
Detroit, Mich.  
February 25 - March 1, 1974

740264

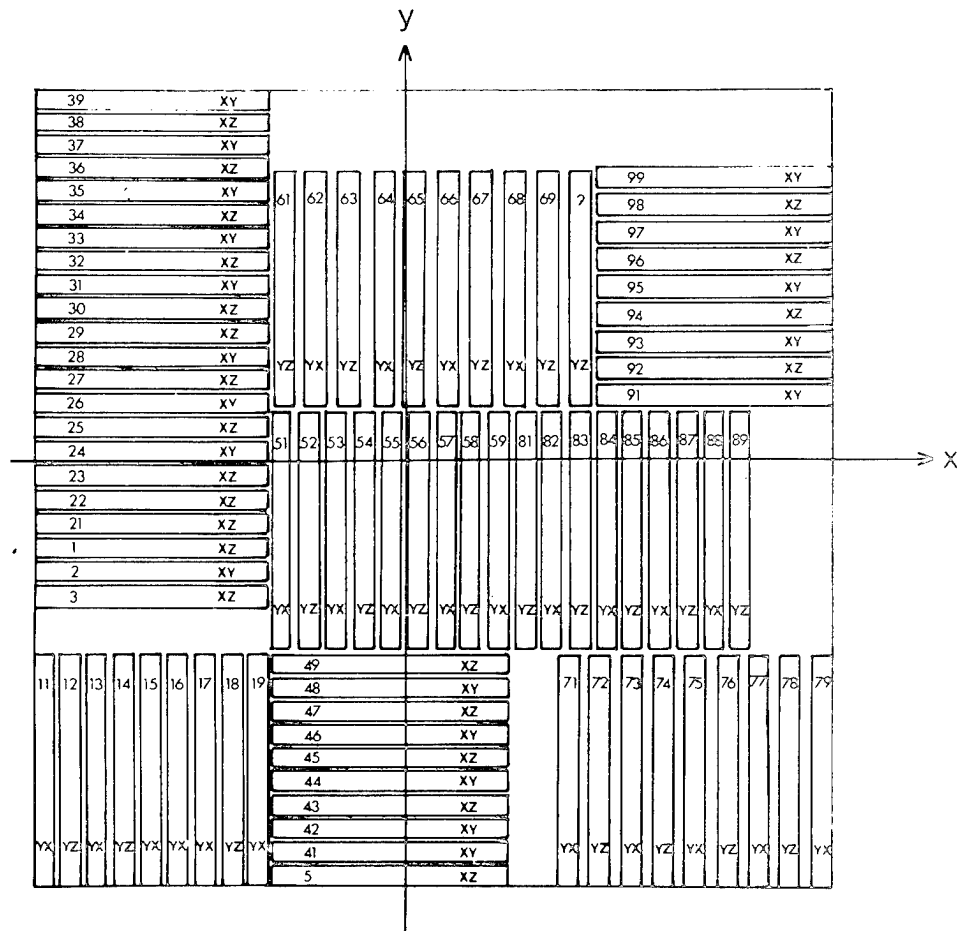
While we suspected that fiber orientation was contributing to the scatter, we did not appreciate the extent. A detailed investigation was instigated on a simple molded plaque ( $305 \times 305 \times 6\text{ mm}$ ) of DMC (15% glass content, 6 m fiber length) to identify the principal factors involved. Eighty-seven test pieces were cut from the plaque (Fig. 1) and their cross-breaking strengths measured using a three point loading system.

Fig. 1 - Positions and orientations of specimens

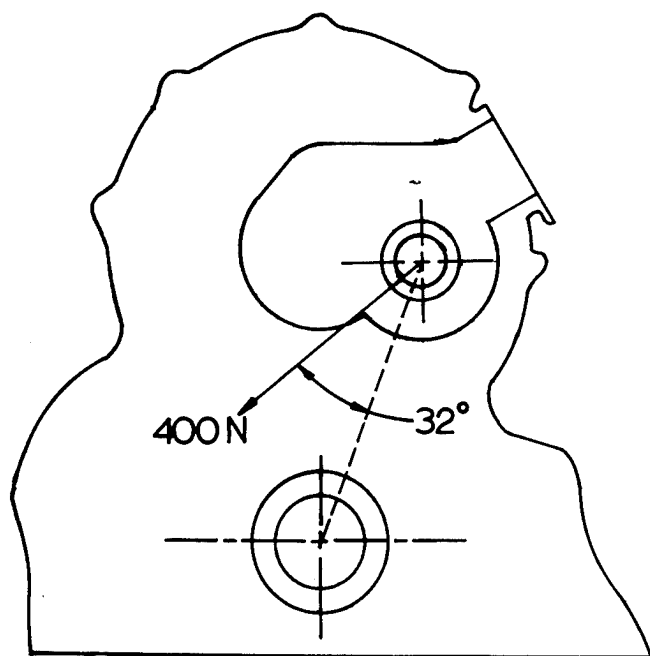
Fig. 7 - Magnitude and direction of load due to fan belt

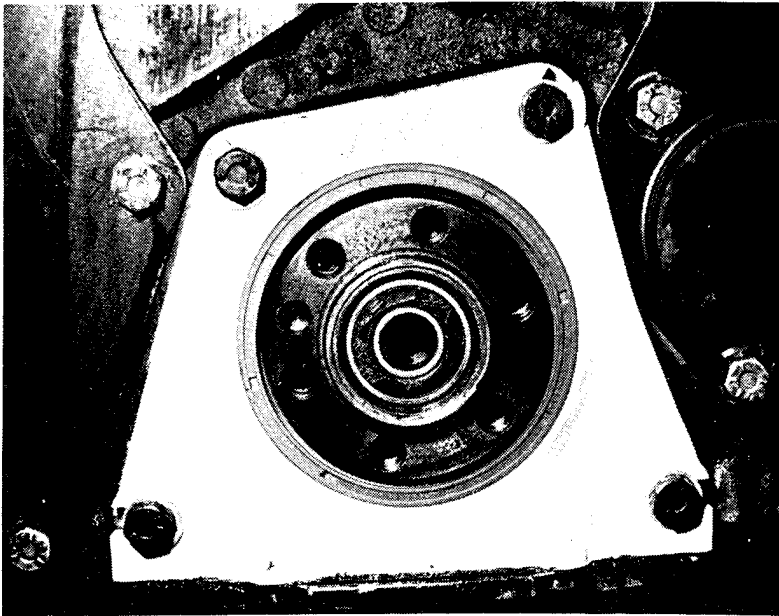
Fig. 13 - Crankshaft rear seal housing assembled to engine

The crankshaft rear seal housing (Fig. 13) supports the crankshaft rear-end rubber seal. Theoretically, the component is unstressed apart from the compressive loads produced when bolting it to the engine block. In practice, stress can also be applied due to a mismatch condition derived when assembling the oil sump pressing to the bottom of the molding.
